Manhole Inspection Summary

Manhole # S15I__022MH

Insp Date: **5/14/09 8:08 AM**

Location Address: **2583 BALTIMORE ST**

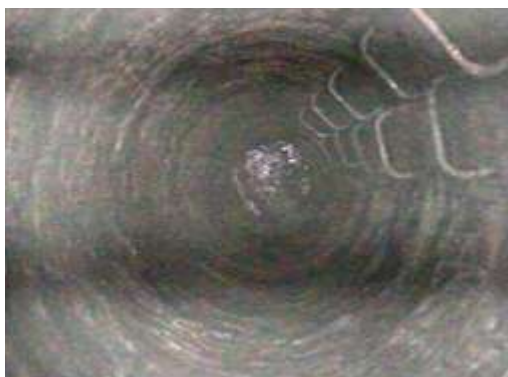
Defect 1

Steps Count: **38** Missing: **6** ☒ **Corroded**

corroded steps, missing

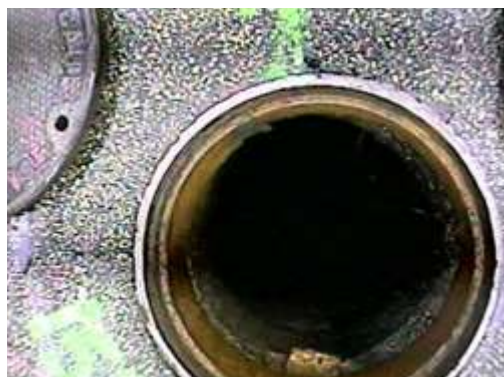
Defect 2

Frame Offset: **3** (in.) Condition: ☒ Sound ☐ Cracked ☐ Leaks

frame offset

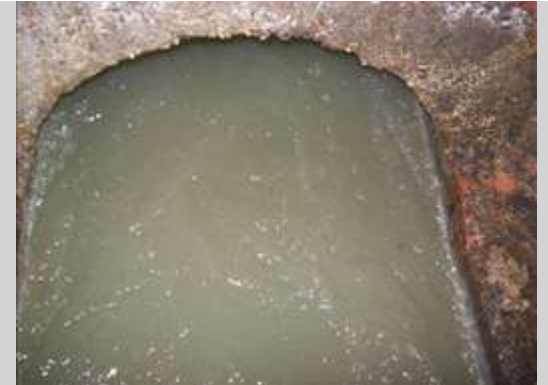
12 O'Clock Outflow

33 in. Circular Gravity Sewer
Pipe Out @ 12 O'Clock

Invert Depth: **48.57** (ft.) Flow Characteristics: **Fast**

Infiltration: **None** Pipe Seal Cond: **Sound**

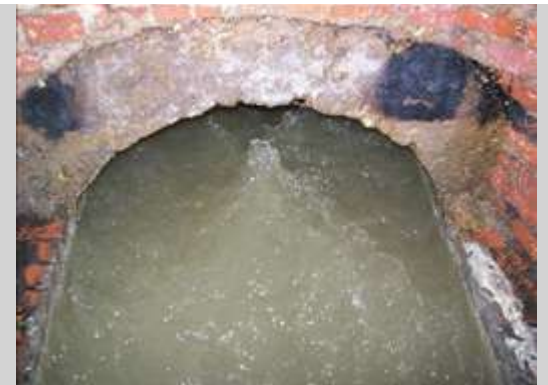
6 O'Clock Inflow

33 in. Circular Gravity Sewer
Pipe In @ 6 O'Clock

Invert Depth: **48.27** (ft.) Flow Characteristics: **Fast**

Infiltration: **None** Pipe Seal Cond: **Sound**
